FINAL REPORT OF SPECIFIC PURPOSE LIDAR SURVEY

LiDAR, Breaklines and Contours for Nassau County, Florida

State of Florida
Division of Emergency Management
Contract 07-HS-34-14-00-22-469
and Add-On Agreement with
Nassau County, Florida

October 30, 2009

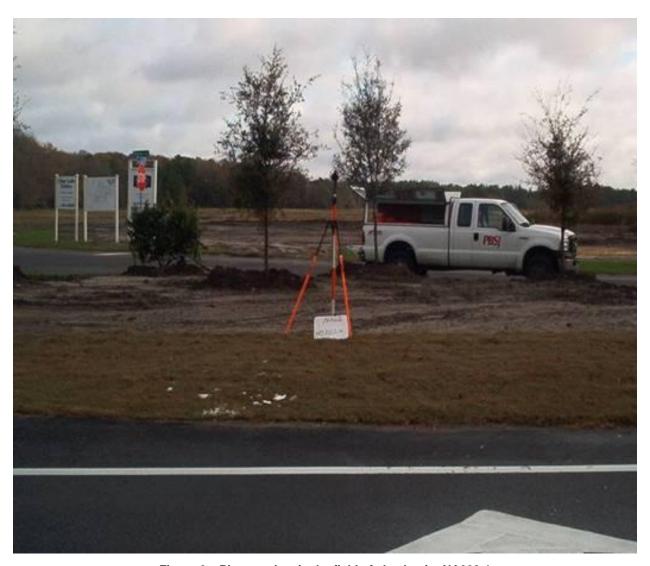
Checkpoint NA022-1, a Category 1 point was not used in the vertical accuracy assessment due to landscaping work that the changed the terrain in the vicinity of the point between the time the LiDAR was acquired and the check points were surveyed. Figure 6 below shows the ground conditions at the time the point was surveyed.

Figure 6 – Picture taken in the field of checkpoint NA022-1

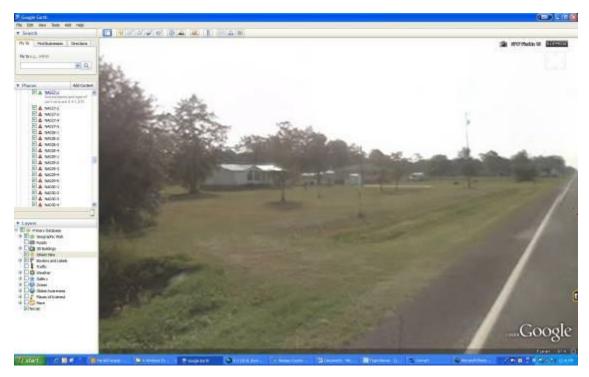
Checkpoint NA027-1, a Category 1 point was not used in the vertical accuracy assessment due to proximity to road ditch

Figure 7 – NAO27-1, vertical image from Google Earth (approx. point location indicated by green triangle)

Figure 8 – NA027-1, Perspective image for Google Earth

Figure 9 - NA027-1, Ground points and cross section

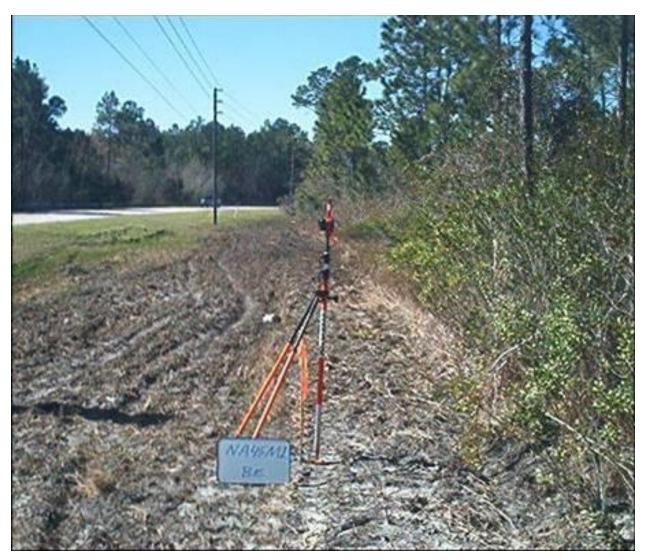
Checkpoint NA045-1, a Category 1 point was not used in the vertical accuracy assessment due to being located on uneven terrain and proximity to tree line.

Figure 10 - NA045-1, survey field picture

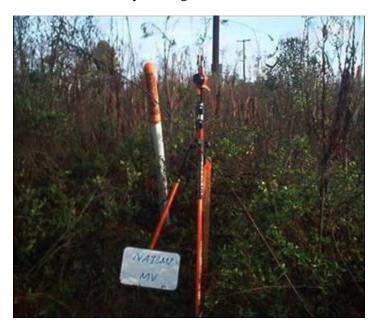
Checkpoint NA013-2, a Category 2 point was not used in the vertical accuracy assessment due to being located in a low confidence area of very dense ground cover.

Figure 11 - NA013-2, survey field picture

Figure 12 - NA013-2, survey field picture

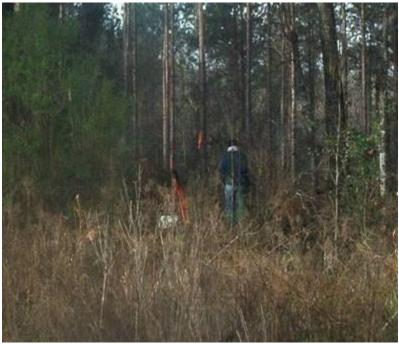
Checkpoint NA031-3, a Category 3 point was not used in the vertical accuracy assessment due to being located in a low confidence area of very dense ground cover.

Figure 13 - NA031-3, survey field picture

Figure 14 – NA031-3, ground points and profile

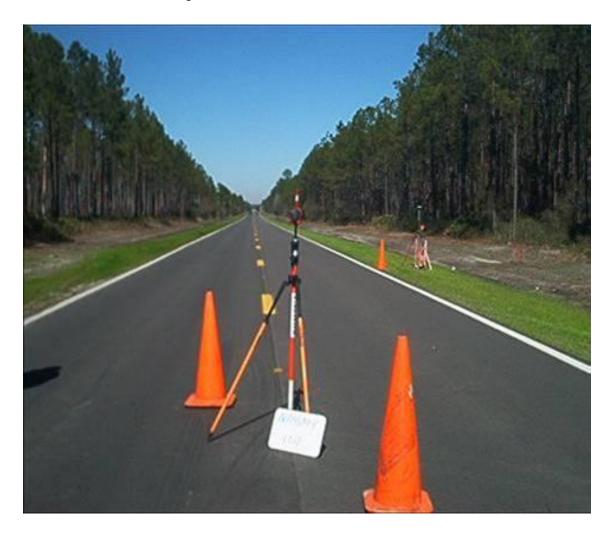
Checkpoint NA046-4, a Category 4 point was not used in the vertical accuracy assessment due to being located on new asphalt pavement, which has a tendency to absorb the laser pulse resulting in negative elevation values in the 1-5 cm range.

Figure 15 - NA031-3, ground points and profile

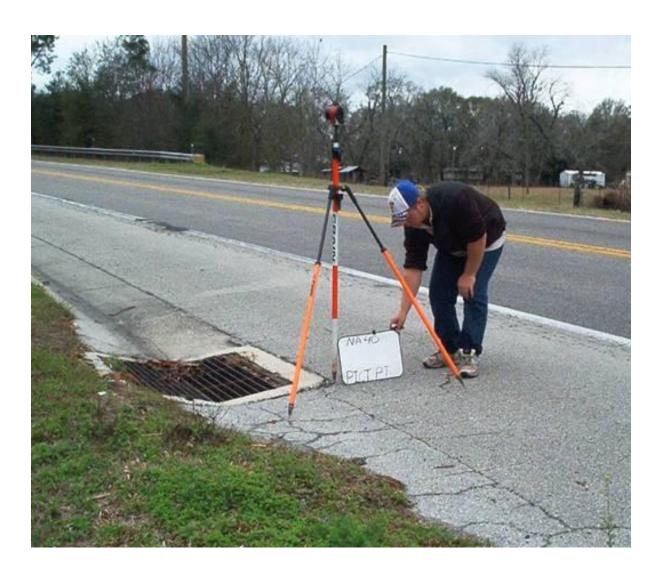
Checkpoint NA040-5, a Category 5 point was not used in the vertical accuracy assessment due to being located next to a drop inlet.

Figure 16 - NA040-5, Survey field picture

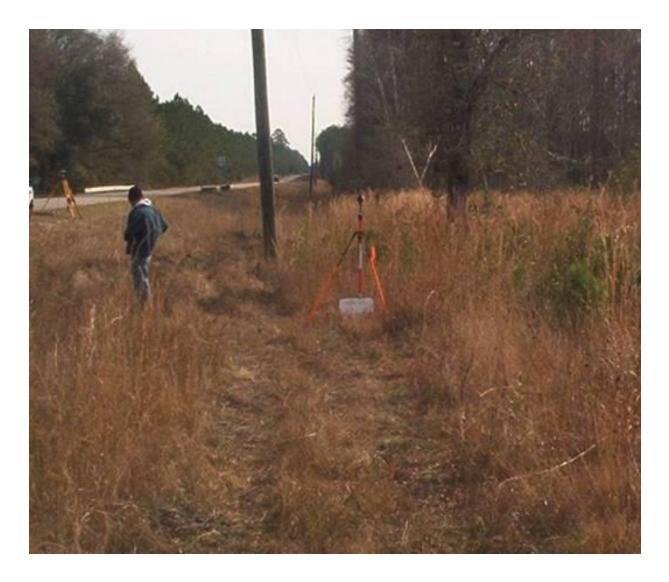
Checkpoint NA029-1, a Category 1 point was actually located in an area of tall weeds and brush and was moved to Category 2

Figure 17 - NA029-1, Survey field picture

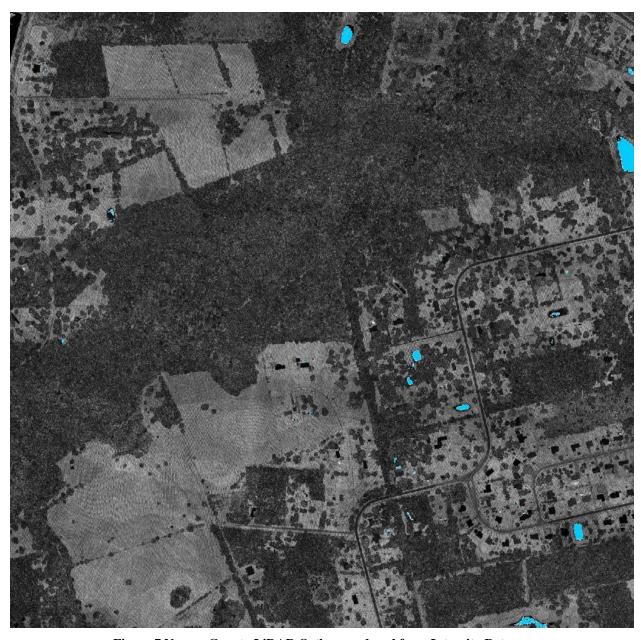
- 3. Data Void/ Gap Checks-The imported .LAS files were used to create LiDAR "orthos". The LiDAR orthos were one of the tools used to verify data coverage and point density, to check for data voids or gaps, and to use as reference data during checks for data anomalies and artifacts. This product is not intended to be a project deliverable. The orthos were derived from the Full Point Cloud elevations and LiDAR pulse return intensity values. The intensity values were used as delivered with no normalization applied. Due to the point density of the original collection, the orthos were produced at a 1.2m pixel for the entire area of interest (see Figure 1).

Figure 7 Nassau County LiDAR Orthos produced from Intensity Returns

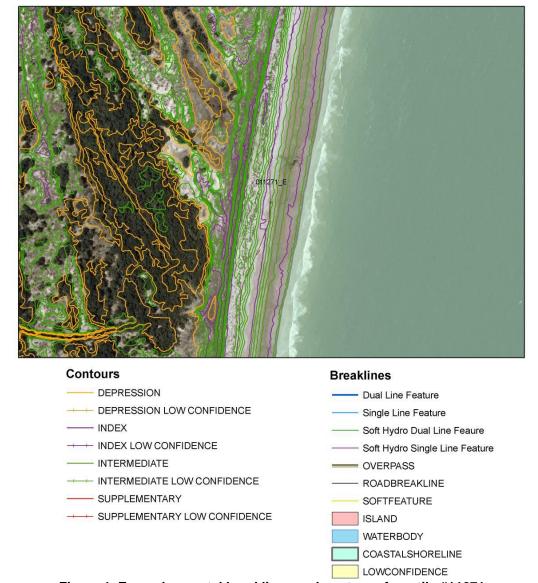
Coastal shorelines are correctly captured as two-dimensional polygon features, extracted from the LiDAR data and not from digital orthophotos, except for manmade features with varying heights such as seawalls which are captured as three-dimensional breaklines. Coastal breaklines merge seamlessly with linear hydrographic features. Shorelines continue beneath docks and piers. There is no "stair-stepping" of coastal shorelines. Figure 1 shows example coastal breaklines and contours.

Figure 1. Example coastal breaklines and contours from tile #11271

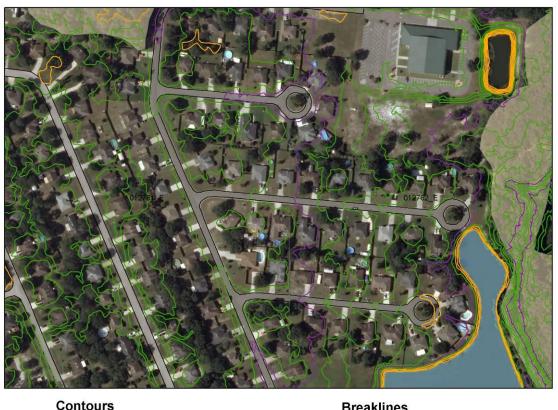
Road edge of pavement features are correctly captured as three-dimensional breaklines on both sides of paved roads. Box culverts are continued as edge of pavement unless a clear guardrail system is in place; in that case, culverts are captured as a bridge or overpass feature. Each vertex maintains vertical integrity. Figure 4 shows example breaklines and contours of road features.

Figure 4. Example road feature breaklines and contours from tiles #012761 and 012762

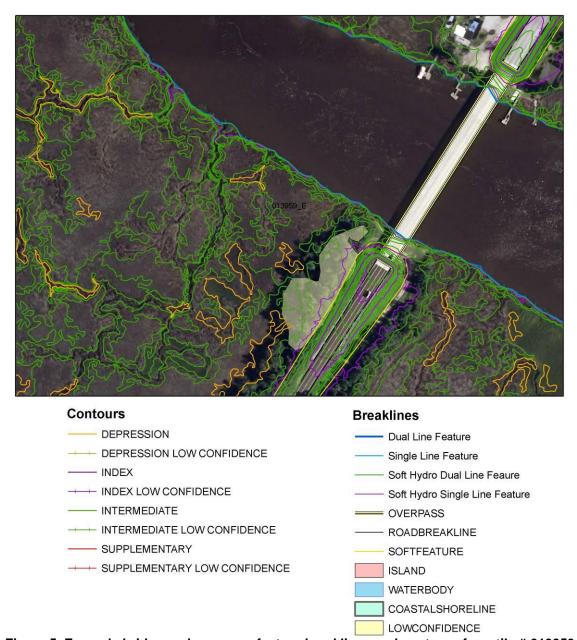
Bridges and overpasses are correctly captured as three-dimensional breaklines, capturing the edge of pavement on the bridge, rather than the elevation of guard rails or other bridge surfaces. Each vertex maintains vertical integrity. Figure 5 shows example breaklines and contours of bridge and overpass features.

Figure 5. Example bridge and overpass feature breaklines and contours from tile # 013959
